DEPARTMENT OF TRANSPORTATION

Contract #: 04-0120F4Cty: SF/ALA Rte: 80 PM: 13.2/13.9File #: 69.28**WELDING INSPECTION REPORT****Resident Engineer:**Pursell, Gary**Address:** 333 Burma Road**City:** Oakland, CA 94607**Report No:** WIR-013124**Date Inspected:** 11-Apr-2010**Project Name:** SAS Superstructure**OSM Arrival Time:** 700**Prime Contractor:** American Bridge/Fluor Enterprises, a JV**OSM Departure Time:** 1900**Contractor:** Zhenhua Port Machinery Company, Ltd (ZPMC), Changxing Island **Location:** Shanghai, China

Bridge No: 34-0006**Component:** OBG Trial Assembly**Summary of Items Observed:**

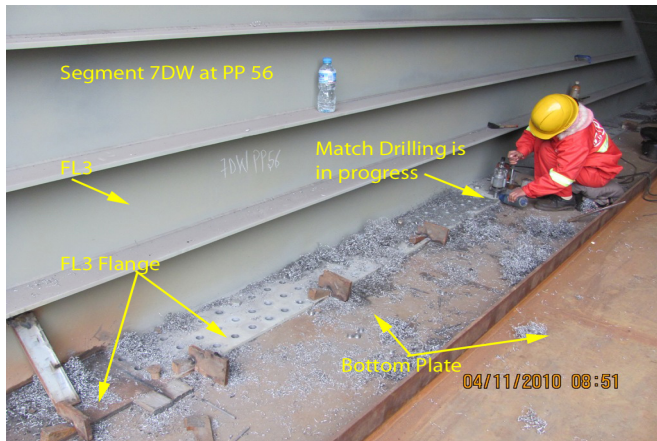
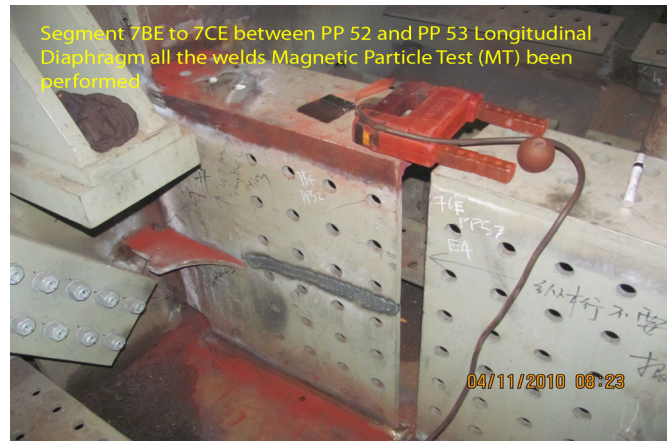
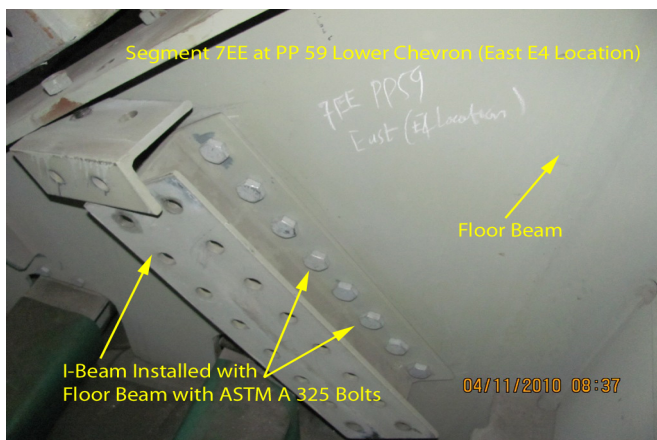
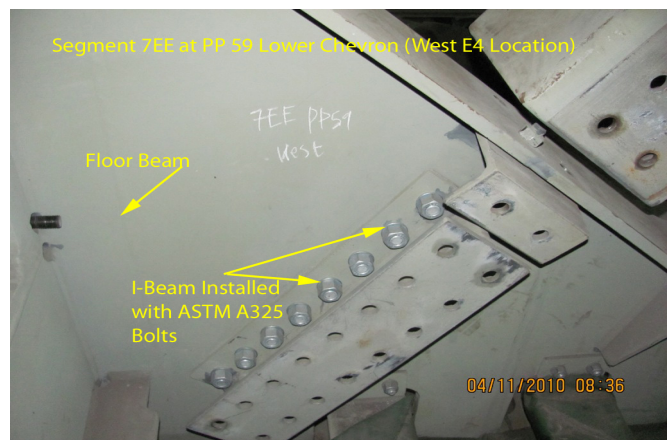
This QA Inspector observed ZPMC personnel performing Magnetic Particle Test (MT) at all the welds of Longitudinal Diaphragm to Longitudinal Diaphragm at E4 location. Please refer the pictures attached below for more comprehensive details.

This QA Inspector observed ZPMC personnel at Segment 7EE at Panel Point (PP) 59 Lower Chevron I-Beam Installation to Floor Beam by means of ASTM A 325 Bolts was in progress at E4 Location. Please refer the pictures attached below for more comprehensive details.

This QA Inspector observed ZPMC personnel at Segment 7DW between Panel Point (PP) 56 to PP 57 and PP 58 FL3 flange to Bottom Plate area match drilling is in progress. Please refer the pictures attached below for more comprehensive details.
